RELATION H/T IN STRUCTURES OF BAHÍA DE CARAQUEZ AND THE 2016 EARTHQUAKE

R. Aguiar ^(1,2), V. Zambrano ⁽²⁾

RELACIÓN H/T EN ESTRUCTURAS DE BAHÍA DE CARÁQUEZ Y EL TERREMOTO DE 2016

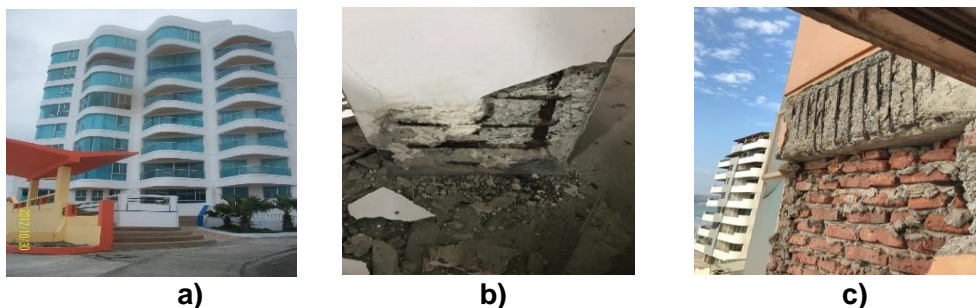
- The Vigia Building

Figure 3. (a) The Vigia Building of 10 floors of HA; (b) Lost of covering in parking's column, strong corrosion in the rods of reinforcement; (c) High corrosion index in girders of elevator, stirrup without confinement.

The Watchtower building has a relation of average H/T of 26 is observed that there was moderated damage in structural elements in spite of the fact that a high corrosion index exists in the armor.

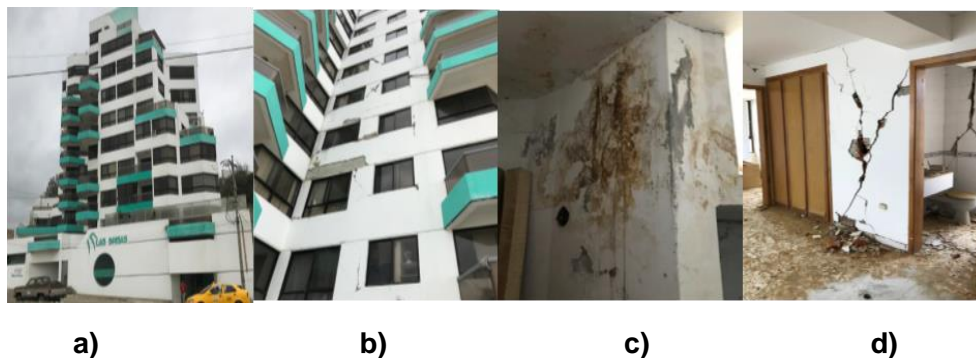
- The Brisas Building

Figure 4. (a) The Brisas Building of 10 floors of reinforced concrete; (b) Lost of covering in some structural elements; (c) High corrosion index in girders; (d) Damages in masonry.

The Brisas building has a relation of average H/T of 30.80 is observed that there was corrosion in the steel of reinforcement so much of girders and columns in subsoil. Great damage in not structural elements.

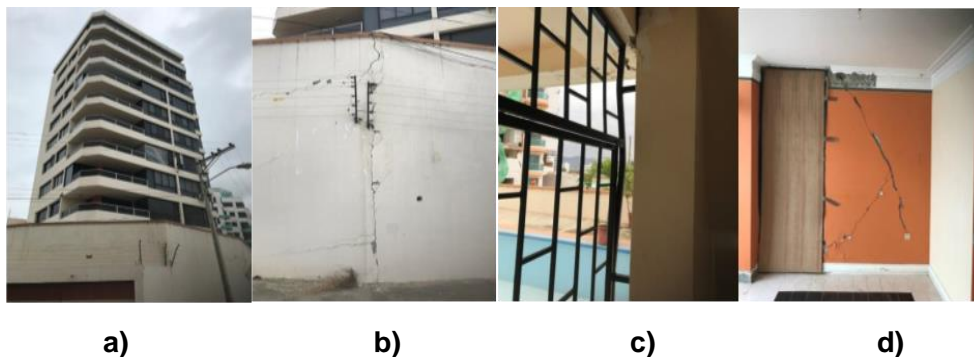
- **The Horizonte Building**

Figure 5. (a) The Horizonte Building of 10 floors of reinforced concrete; (b) The wall of containment presents a vertical fissure; (c) The perimetrales flounces suffered accession and product of this observes bulge in the door of access to the area of swimming pool; (d) Minor damages in internal masonry and broken windows.

The Horizonte building has a relation of average H/T of 22.25 are observed such damages as slight accession in perimetrales flounces, slight damages in masonry.

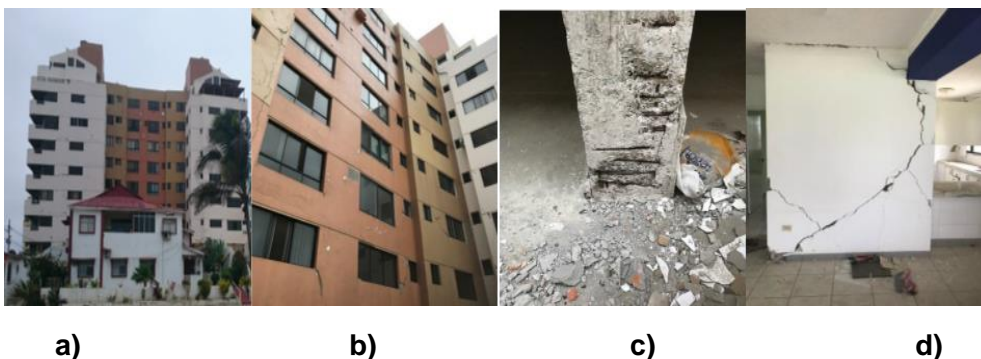
- **Two Hemisferios Building**

Figure 6. (a) Two Hemisferios building of 9 floors of reinforced concrete; (b) Detachment of covering in front; (c) Extensive damage in columns of social area; (d) Severe damages in interior and slight masonry in exterior masonry.

The Two Hemisferios building has a relation of average H/T of 12.60 structural damages are observed in the columns and in girders of some floors; to more of that it had damage in not structural elements.

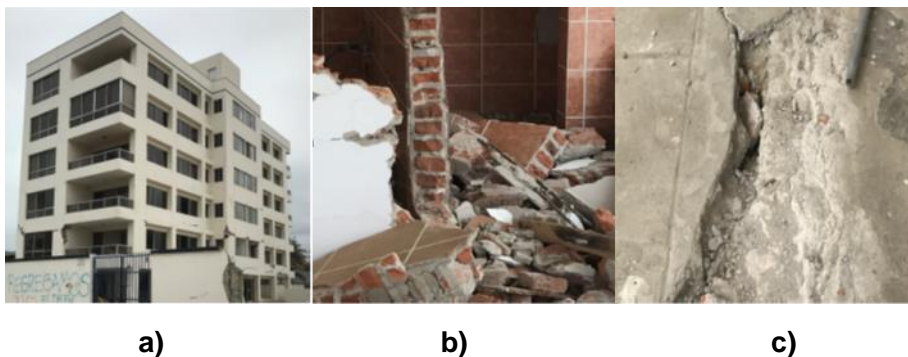
- The Delfín Building

Figure 7. (a) The Delfín Building of 6 floors of reinforced concrete; (b) Detachment of covering in facade; (c) Severe damage in internal masonry.

The building Delfín has a relation of average H/T of 21.0 the damages that observed are severe in internal masonry, detachment of covering in facade, besides fissures in slab for cutting fault. Building was demolished post earthquake.

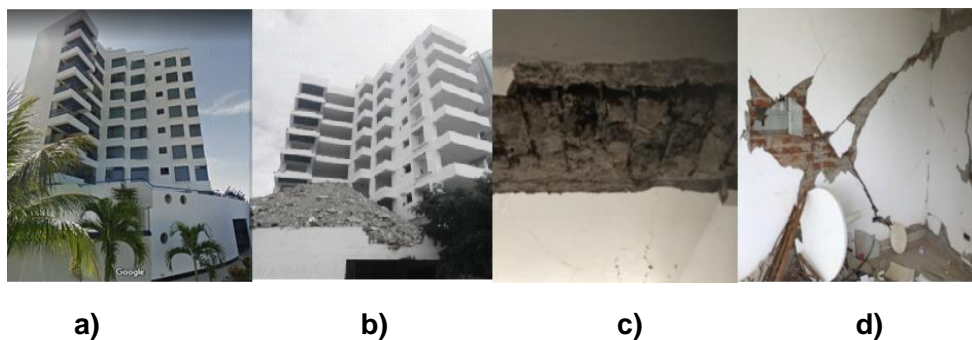
- The Almirante Building

Figure 8. (a) The Almirante Building of 9 floors of reinforced concrete located in Bahía de Caráquez city; (b) Detachment of covering and fissures in front; (c). Steel of reinforcement corroded in girder of social area; d). Detachment of internal masonry.

The Almirante building has a relation of average H/T of 20.90 the damages that are observed are severe in internal masonry, detachment of covering in facade, and damage in some of the columns of the social area and of the parking, in addition the reinforcement presents corrosion.

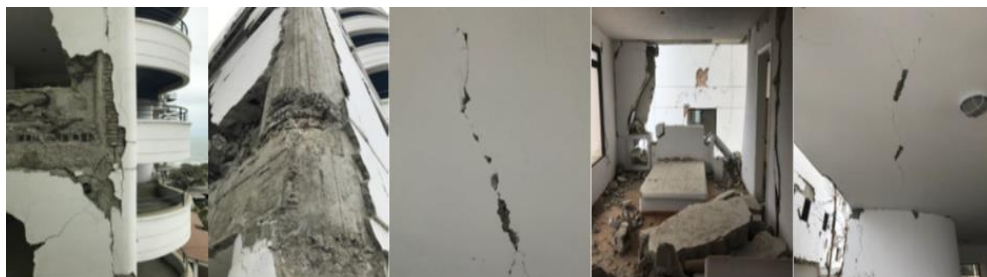
- **The Mykonos Building**

Figure 9. (a) The Mykonos Building of 10 floors of reinforced concrete; (b) Detachment of the covering of the column to the high of the whole floor.; (c) Failure of a vain of slab, close to nerve of the same (rotated photography); (d) Furniture store of concrete (e) Longitudinal fissure close to girder band.

The Mykonos building has a relation of average H/T of 19.45; the building presents strong damages in masonry and in some structural elements.

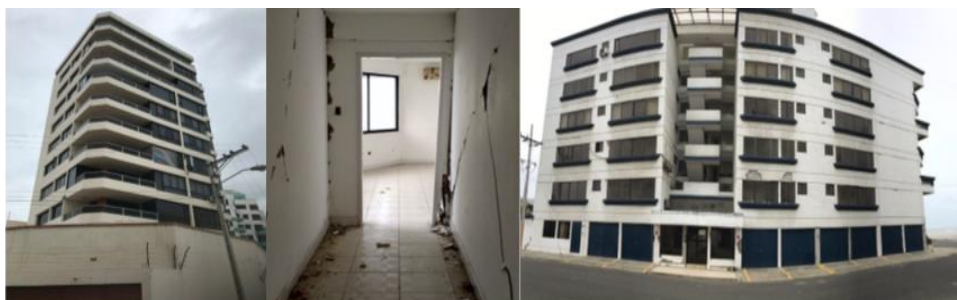
- **The Pirata Building**

Figure 10. (a) The Pirata building of 7 floors of reinforced concrete; (b) Cracking in masonry; (c) Detachment of covering in frontal and posterior facade.

The building Pirata has a relation of average H/T of 22.90; though it had cracking in masonry these did not collapse.

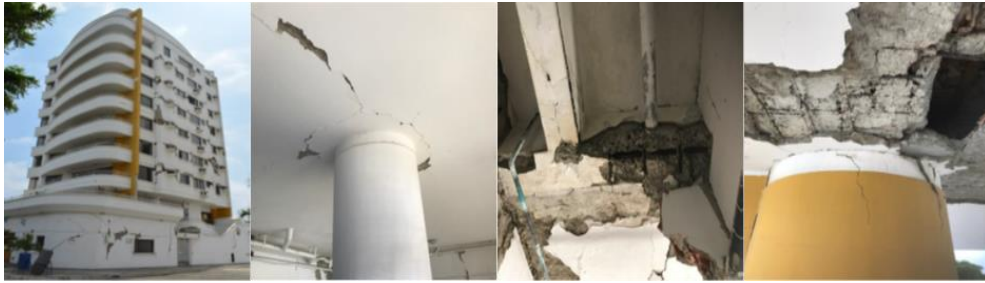
- The Salango Building

Figure 11. (a) The Salango building of 10 floors of reinforced concrete; (b) Failure for punching and longitudinal fissure in tile low close to the nerve; (c) Corrosion in structural elements of slab of cistern and slab of parkings; (d) Low tile in ground floor with corroded steel and without adherence.

The Salango building has a relation of average H/T of 23.25; it presents damages in masonry in some cases collapsed; is observed in addition steel of reinforcement corroded in girder that supports cistern.

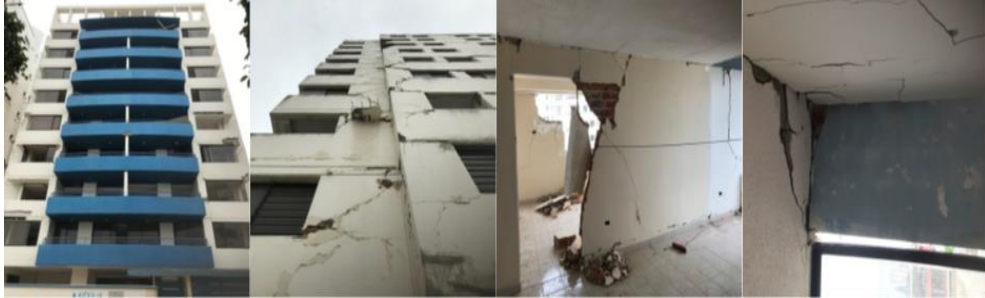
- The Spondylus Building

Figure 12. (a) The Spondylus Building of 9 floors of reinforced concrete; (b) Building's facade, major damage of masonry is not observed.; (c) Collapsed masonry supported by an electrical duct; (d) Cracking in relieved slab on facade window.

The Spondylus building has a relation of average H/T of 18.60; the damages are observed in masonry and detachment of covering in front, fissure in slab and masonry without vertical reinforcement not horizontally.

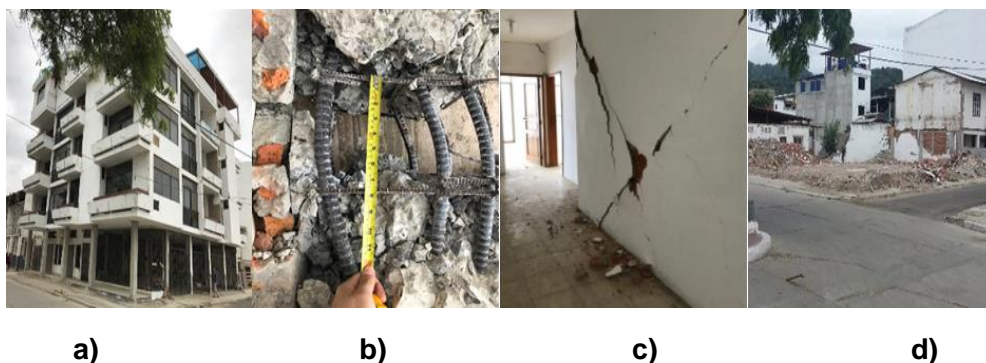
- The Cevallos Building

Figure 13. (a) The Cevallos building of 5 floors of reinforced concrete. (b) The formation of kneecaps repeats itself in 7 columns of ground floor in the facade posterior of the building; (c) Cracking of masonry they change according to the level of floor; (d) Demolished structure.

The Cevallos building has a relation of average H/T of 9.35; were observed damages and presence of plastic kneecaps in 8 columns. Poor detail in stirrups of confinement.

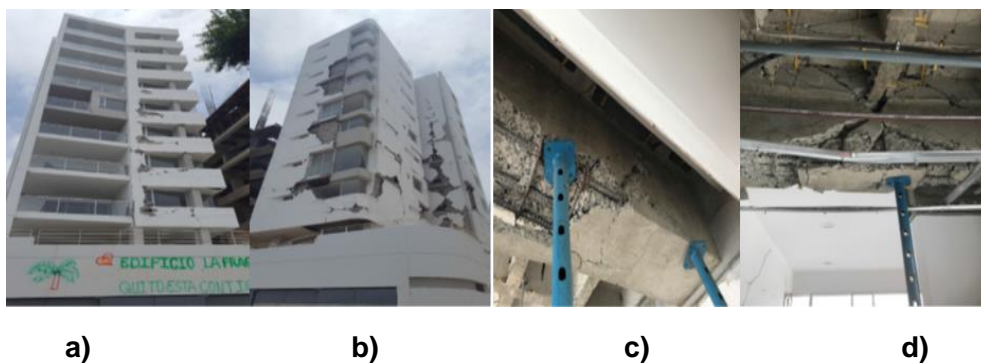
- The Fragata Building

Figure 14. (a) The Fragatas Building of 10 floors of reinforced. (b) Detachment of covering in frontal and lateral facade; (c) Failure for butcher close to the right support of the girder; (d) Damage in girders and slab for butcher's effect.

The Fragatas building has a relation of average H/T of 28.60; damage in masonry. The photographs of the figures 14 (c) and (d) correspond to a short girder that penetrated into the not linear range into several floors. This building had damage in the columns of the social area, where the swimming pool was situated. It had a behavior of agreement to the philosophy of design and it was possible to reinforce (Aguiar, 2017) but it was demolished.

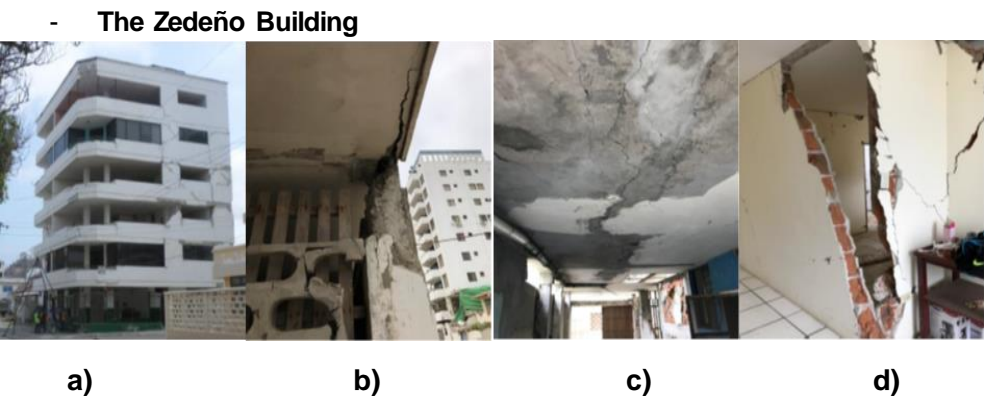
Figure 15. The Building Zedeño; **(a)** After The earthquake; **(b)** Damage in columns; **(c)** Crackings in panel of slab; **(d)** Collapse in masonry.

The building Zedeño has a relation of average H/T of 9.40; it presents damage in the top part of some columns of the ground floor, in slab, partial collapse of masonry. It is important bear in mind that the floors 3, 4 and 6 were not finished of repairing, after the affectation that had the building in the earthquake of 1998. In that way they had less weight during the earthquake of 16 A, which helped it in its behavior.
